# The Dowdles' Dream

**An Eagle bus conversion project proved no match for this multiskilled FMCAer and his wife.**

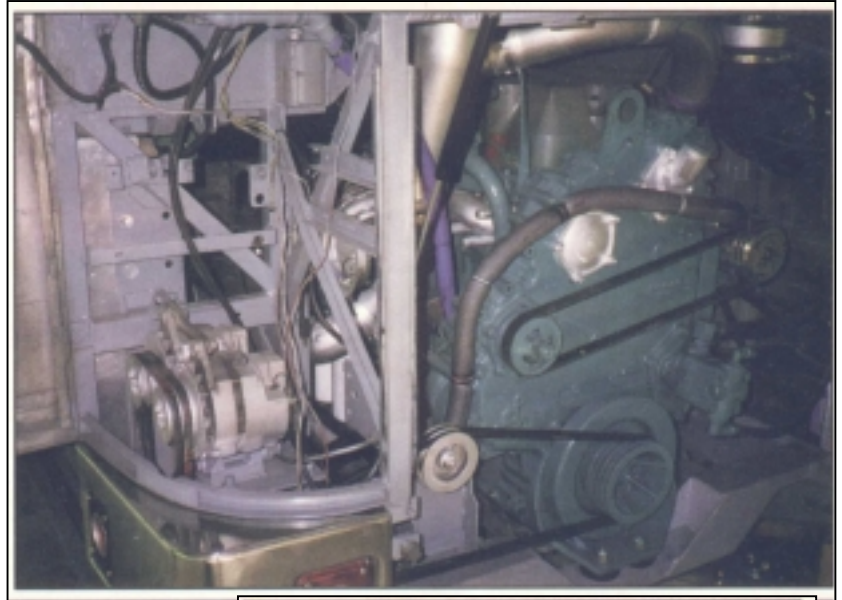
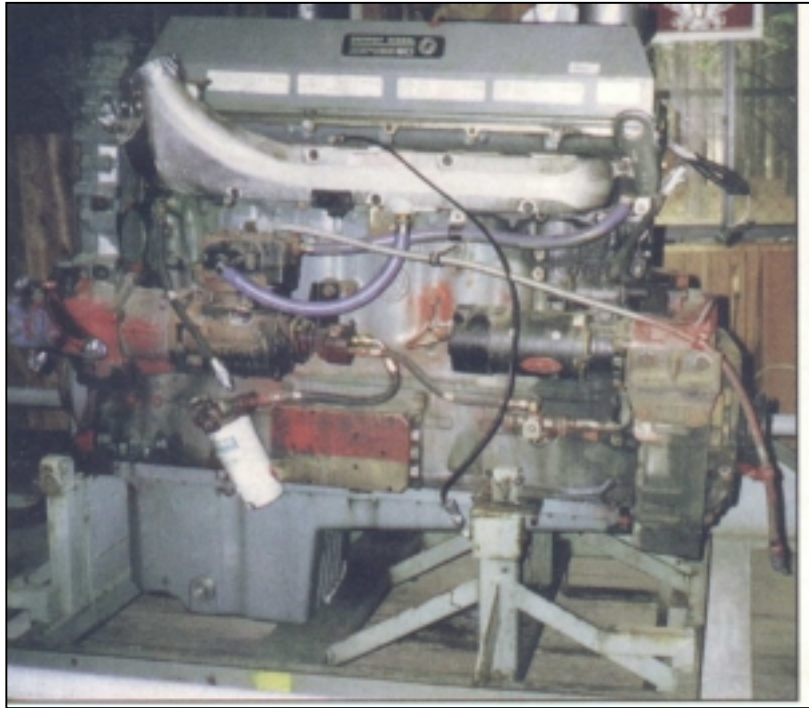
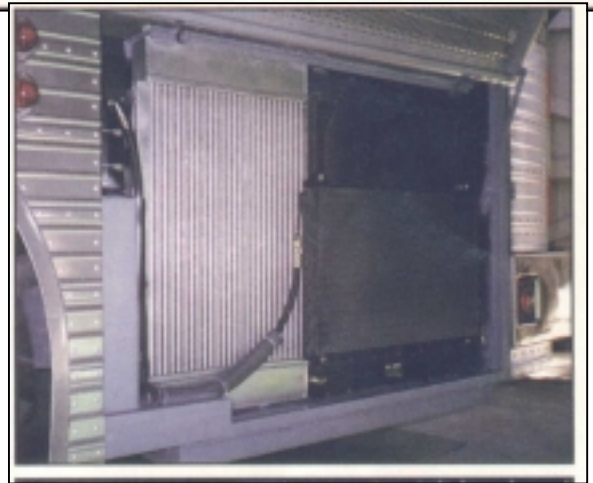
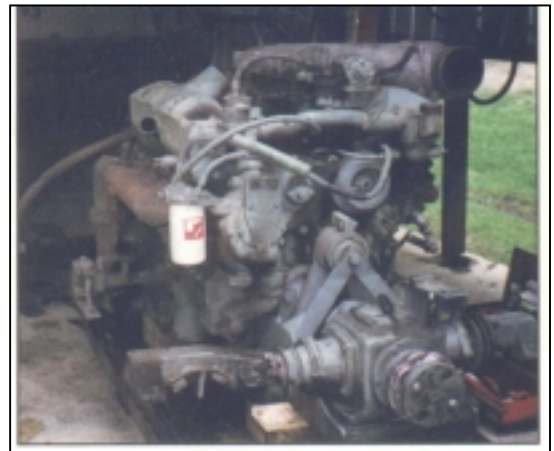
*The mechanics of the Dowdles' conversion are illustrated here in various stages. One of the major changes Leon made was to remove the old Detroit Diesel 8V71 engine and replace it with a Detroit Diesel Series 60 engine (above). Changes were made to the Allison 740 transmission to adapt it to the higher-torque engine, and a new radiator and charge air cooler were installed.*
