GENERATOR FIRE:

the experience, the repair, and the prevention

Ed Gurdjian and Carol Maxwell
RvTechStop.com October 2004

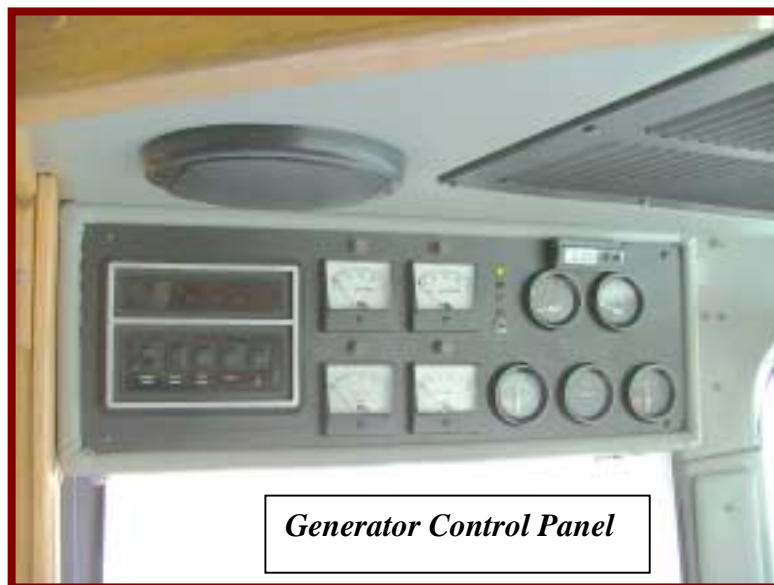
genset wiring included two switches; one to activate the glow plugs (pre-heat), and one for generator ON and OFF (FIG. 1) The first switch is a single-pole-single-throw momentary normally off, the second is a single-pole-double throw momentary center off, and both toggle to ground. The autostart circuit has only two relays. One is used for glow plug activation and the other for starter activation. There is no separate “OFF” relay, so that function is incorporated into the glowplug relay. Combining the glow plug and OFF function into one relay required that the protection afforded by the separate glow plug switch in our application had to be disabled. Ultimately, rewiring the generator to make it compatible with this particular autostart system allows the starter solenoid to run-on if the starter relay

which could result in a catastrophic fire. First, he studied two frequently used wiring plans as shown in Figures 1 and 2. Figure 1 uses two switches, which are described above. Figure 2 uses a double-pole-double-throw momentary center off switch, where one pole toggles to ground and the other to 12 VDC. Figure 1 provides 12 VDC to the starter relay only when the glow plug relay is activated, thus offering protection against inadvertent activation of the starter which would allow starter run-on. Figure 2 uses an extra relay detecting the presence of AC to prevent starter run-on. Although each generator manufacturer may have minor variations, their schematics will generally have four or five relays and two or three switches. Some auto-start circuits may require only three relays. He also reviewed the gauges

(FIG 1) he decided to attempt to stop the generator by disconnecting the sense line from the alternator, surmising that the alternator sense line was back feeding 12V. Normally, the

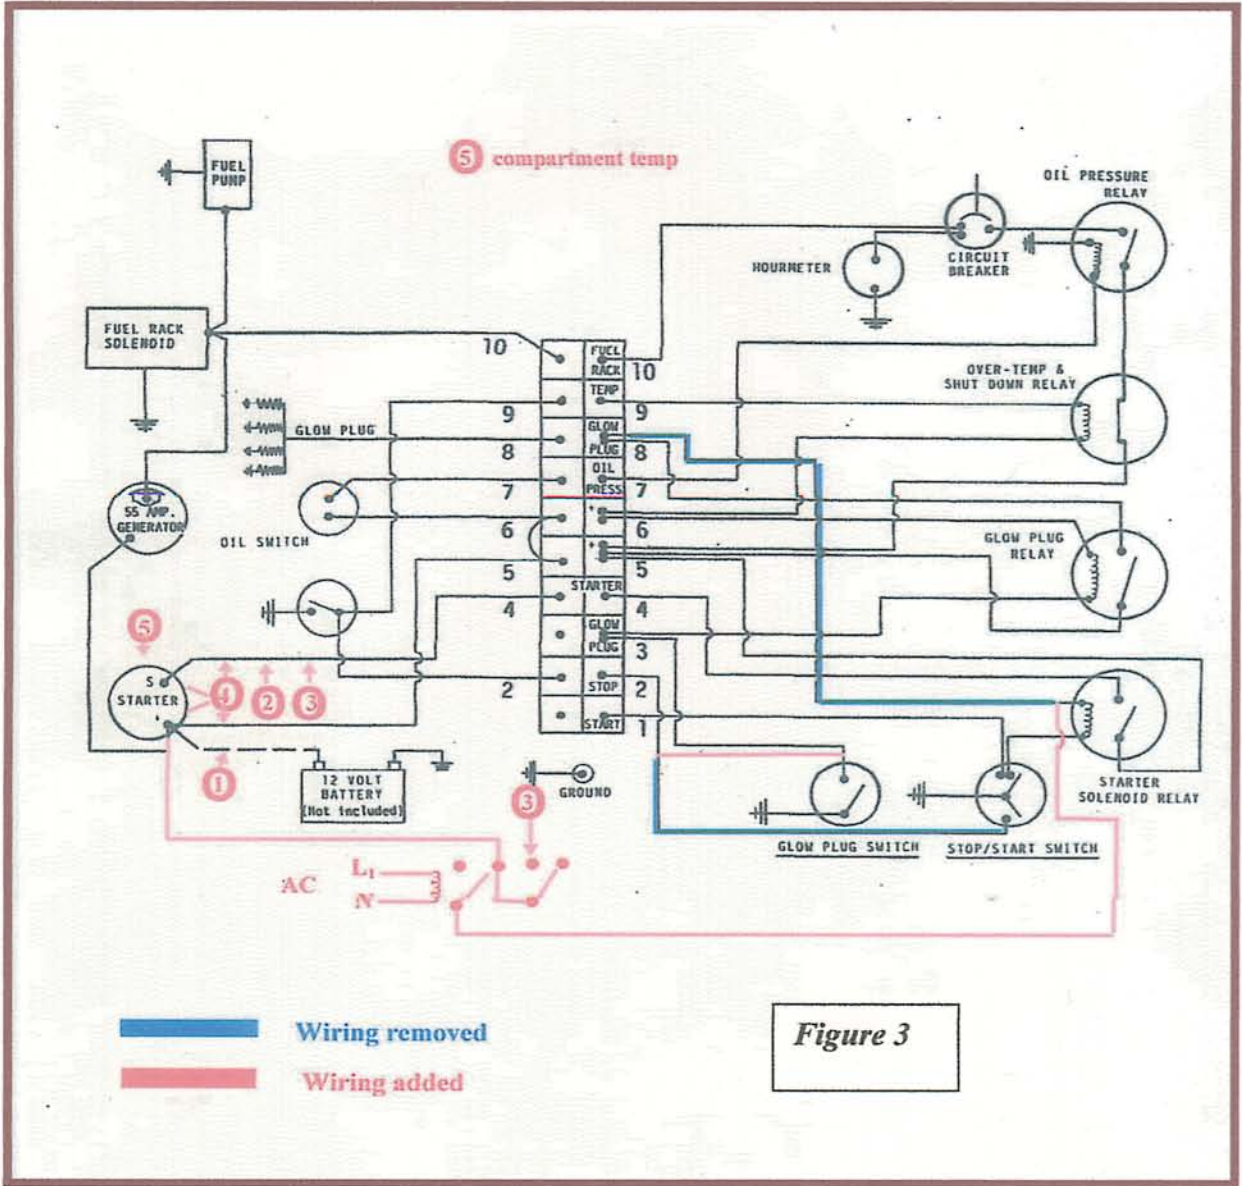
Figure 3

protection devices referenced above, it seems that additional protection may be afforded by the options listed below with locations shown on Figure 3.

Option 1: Use a latching solenoid for powering and de-powering all generator circuits. This manually disables the autostart function and the generator.

Option 2: Place a low amperage fuse in the B+ line to the solenoid. I believe this is a standard protection device in marine applications.

Option 3: Use a wiring protocol that permits B+ to the starter solenoid relay only under limited circumstances such as only when the glowplug relay is activated. Alternatively, use a starter lockout relay that locks out any B+ to the solenoid whenever AC is being generated. In both cases a sticking relay could still cause problems.

Option 4: Use a Klixon type of thermal switch on the starter. This option will prevent extraneous B+ to the starter solenoid from causing starter run-on once the starter case becomes heated. However, it will not prevent starter run-on if the solenoid contacts become fused. To eliminate this rare possibility, the Klixon can be interfaced to a circuit which will trip the latching solenoid supplying B+ to the generator, thereby cutting power to all generator circuits, including the starter.

Option 5: Use thermometers to monitor the temperature of the generator compartment and the starter case.

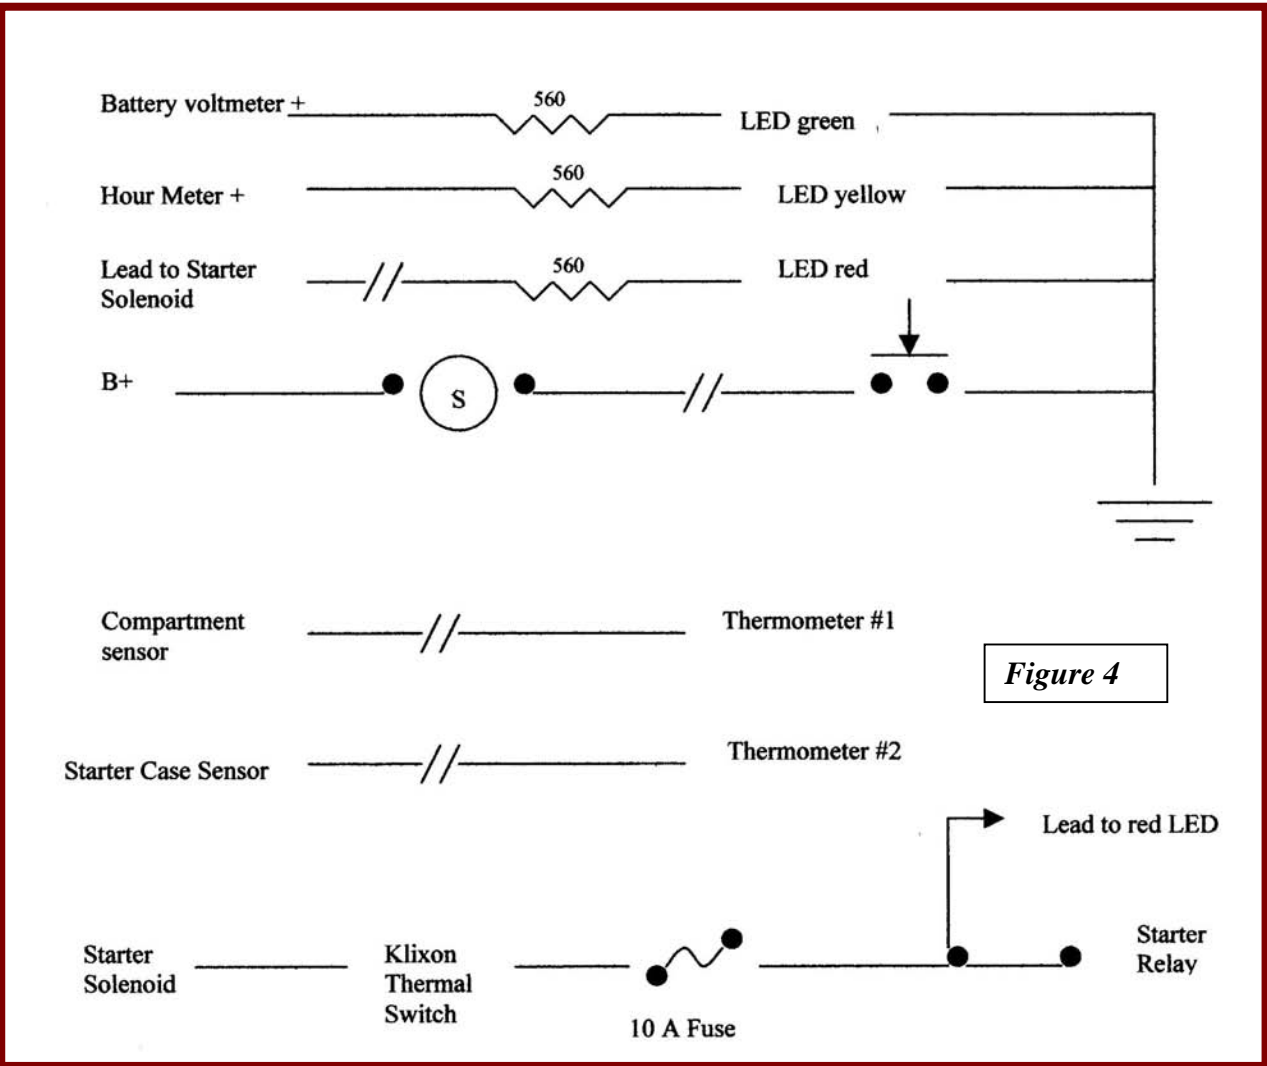
Figure 4 shows the location of circuits for diagnostic LEDs, thermometers, and an ON/OFF latching solenoid for 12V supply. On our coach, a red LED indicates the starter is cranking, a yellow LED indicates the generator is running and AC

is being produced, and a green LED indicates that battery power to the generator is enabled.

Modifying the wiring to add the new circuits will vary in different vehicles. However, in most cases, existing wiring will be modified on the generator, at the generator battery, in the generator control box, and at the remote panel inside the coach. New wires will be added between the generator compartment and the interior control panel. The LEDs, resistors, the momentary switch, and the thermometer display are installed on the control panel. The latching solenoid is installed next to the generator battery on the positive line out of the battery and after the auxiliary start solenoid (jump-start or booster solenoid), if so equipped. The new momentary push-button switch on the control panel controls the latching solenoid. The Klixon is installed directly on the starter case and held in place with a wire or nylon strap. The existing battery cable supplying the starter is moved to one terminal of the normally closed solenoid and a new cable is installed from the solenoid to the starter. One temperature sensor is installed on the starter case and the other is installed in an appropriate location to monitor ambient air temperature.
