# The Dowdles' Dream

**An Eagle bus conversion project proved no match for this multiskilled FMCAer and his wife.**

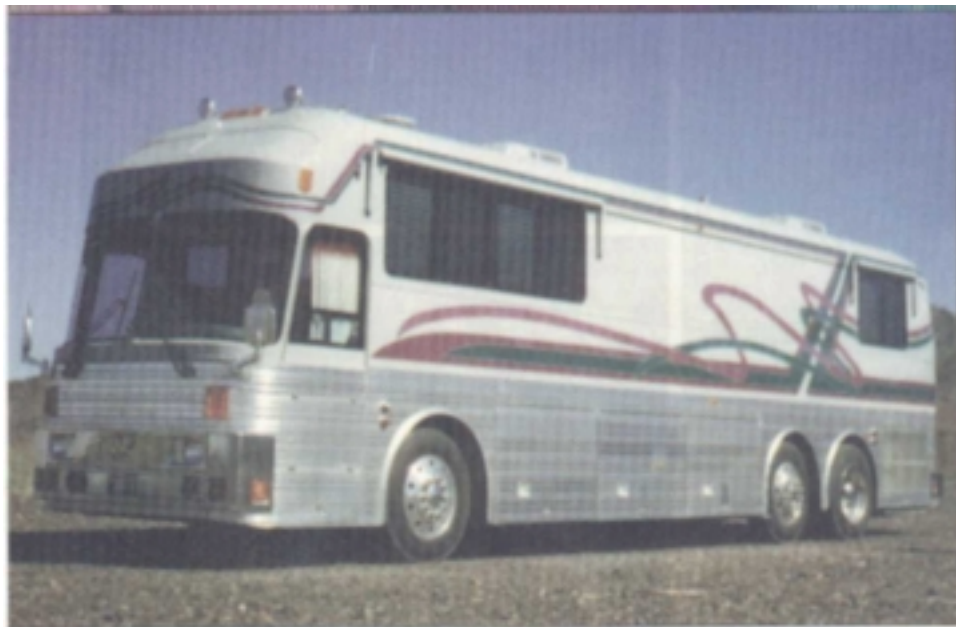
*Leon and Ginny Dowdle performed a Cinderella-like transformation on a 1975 05 Eagle bus. The bus went from cargo and passenger hauler to a sparkling home on wheels.*
