MIDWEST PRODUCTS, INC.

This successful Iowa company rebuilds cooling units for all popular models of RV refrigerators

By Maxwell/Gurdjian
RvTechstop.com

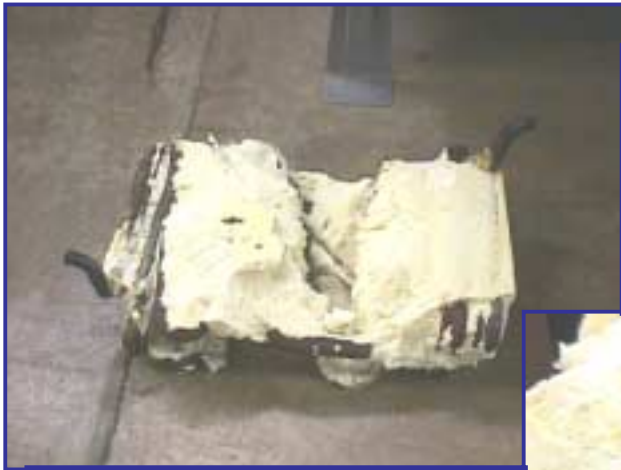
*Above:
Deteriorated evaporator.*

the galvanized units were quite reliable except for the boiler area, they were prone to malfunction if they were not kept level. Sometime between 1974 and 1976, a new style boiler was introduced, perhaps by Norcold. This was an enclosed percolation tube surrounded by liquid. Frigiking of England and Magic Chef of Germany also had enclosed boilers surrounded by liquid and there were seldom any problems with these boilers. Subsequently, Dometic bought much of the tooling from the other manufacturers, but Servex also purchased some of the tooling. In fact, Servex had all rights to Magic Chef and Astral-Frigiking. During this same time, the galvanized pipe was replaced by regular steel tubing, which was painted and encased in polyurethane foam. With a more reliable perc tube, the problems now shifted from the boiler area to the non-galvanized tubing, which is much more susceptible to rust.

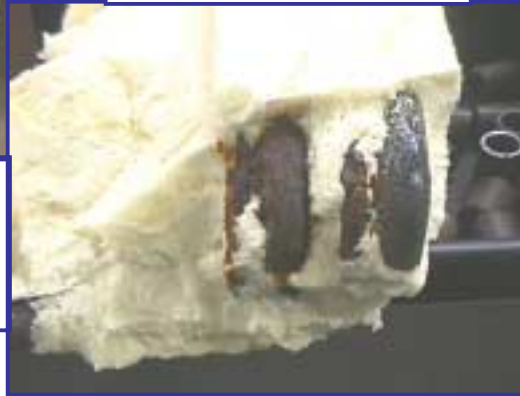
*Below:
Close-up view of damaged evaporator.
Note extensive rust damage.*

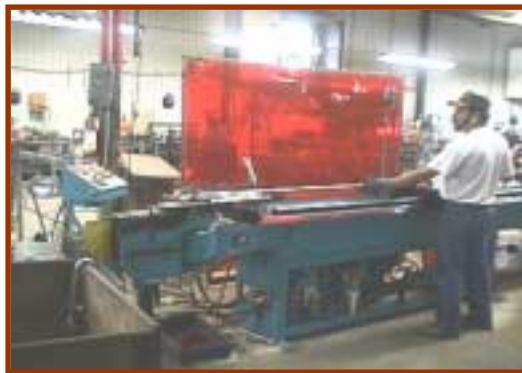
A tube bending machine creates precise duplicates of the evaporator from straight steel pipe.

cut open and flushed to remove the ammonia. The welding department cuts out the damaged area and installs a new complete evaporator. The evaporator assembly is made of hydraulic tubing with a bursting strength of 2,800 psi. A bending machine creates all the correct bends and then the tubing is placed in a jig to position plates and other small tube lines. After

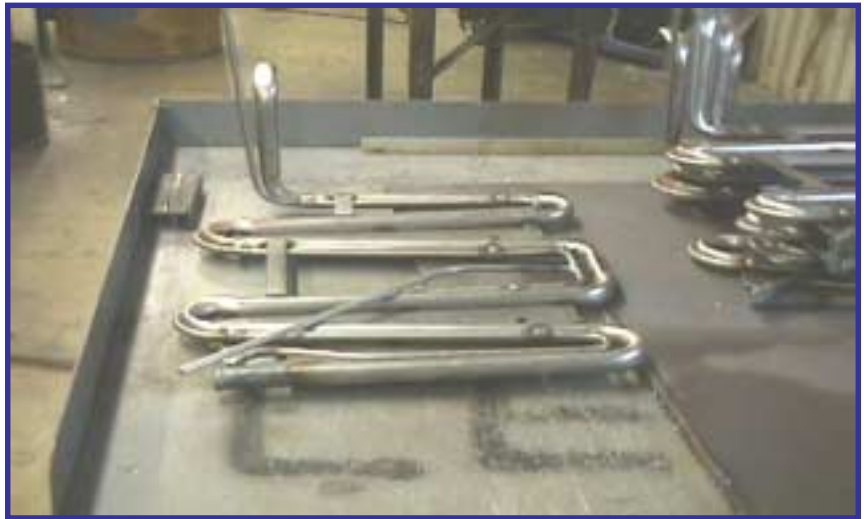
New evaporator

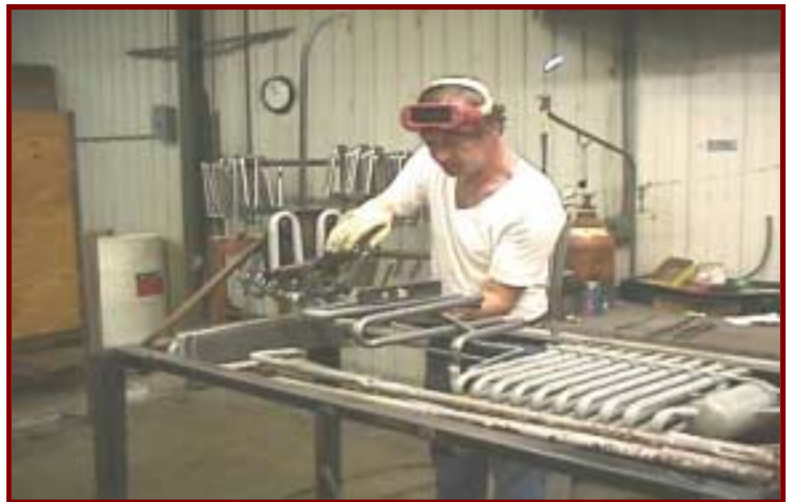
The new evaporator is welded in place

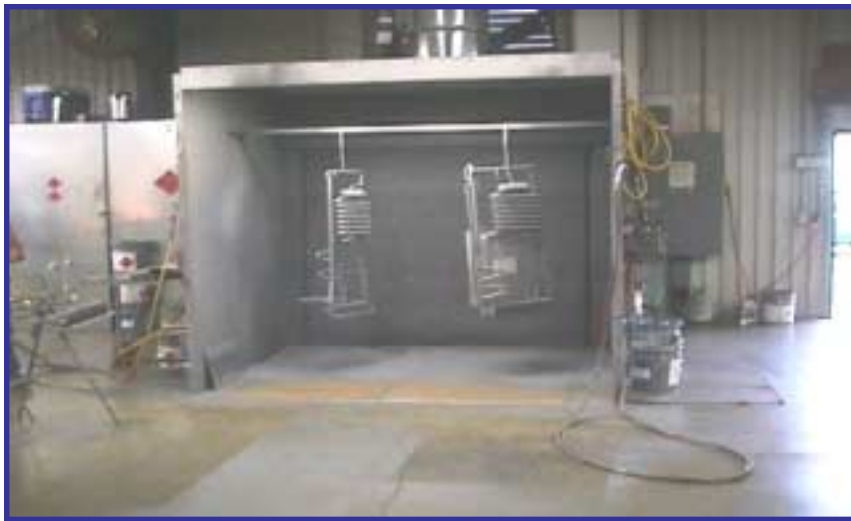
Rebuilt cooling units in the paint booth

it is checked for performance, boiler temperature, and frost pattern. Following a successful test, the unit goes to the paint booth and then to the foaming department. After foaming, the units return to the boiler area where boiler pack is replaced and new insulation is added. The final step is packaging for ship-

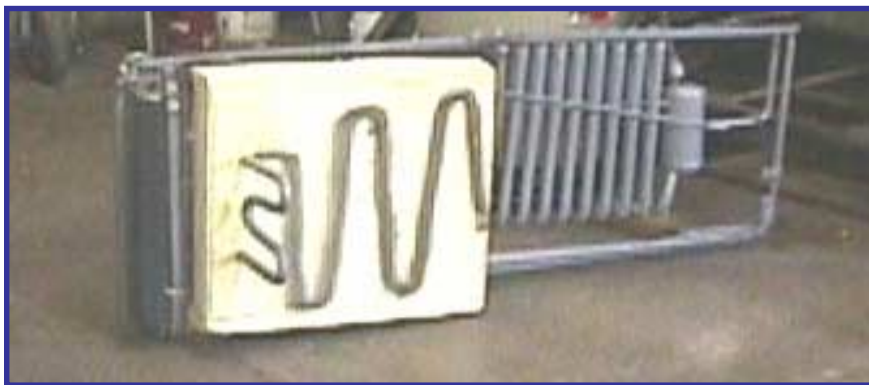
The new evaporator is encased in polyurethane foam
